**COMMERCIAL BUILDING  
SURVEY REPORT**

**THE LIBRARY  
GRANGE ROAD  
BURLEY IN WHARFEDALE  
LS29 7HD**

**PREPARED FOR  
BURLEY PARISH COUNCIL**

Job No. BS1006  
Date: September 2016  
Issue Status: Draft  
Checked By: RMH/DS

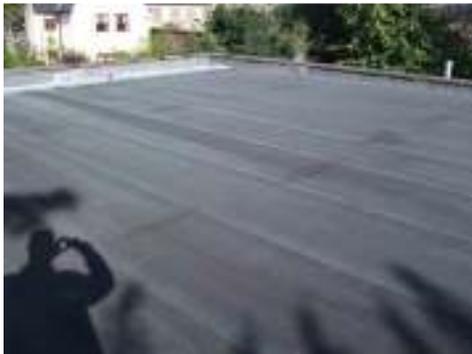
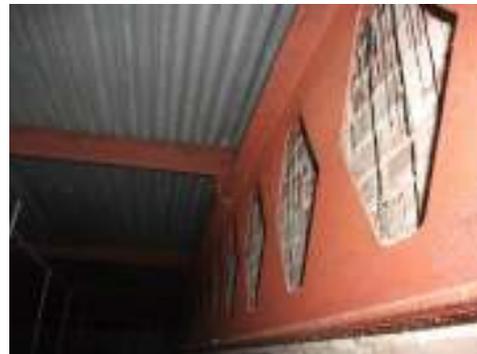
3.2.2 The flat roof over the main library area is constructed from profile metal sheets laid over a series of steel lattice beams and cladding rails and overlaid with plywood sheeting laid to falls and finished with built up bituminous roofing felt.

3.2.3 The flat roof is provided with a perimeter brick and stone faced parapet which is completed with a concrete coping.

3.2.4 Although the flat roof covering did not appear to be leaking at the time of the inspection, the felted flat roof covering has been repaired several times in the past as indicated by the internal water staining noted to the suspended ceiling within the library.

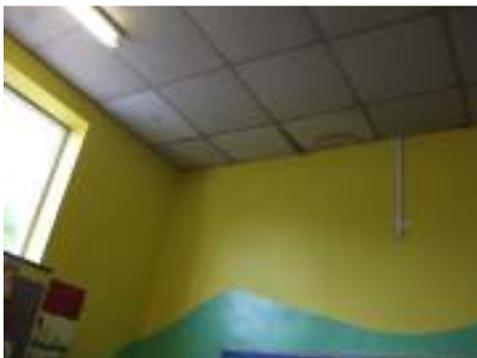
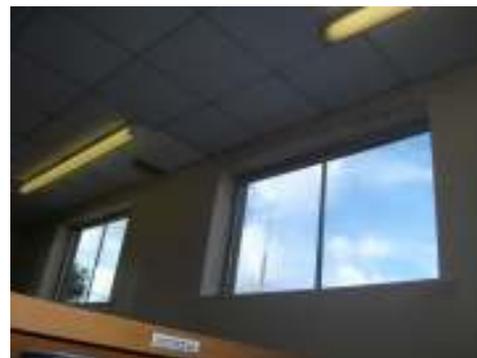
3.2.5 Several points of potential water ingress were noted to the perimeter coping detail and in places, the built up felt has blistered and delaminated and the underlying decking was soft and bouncy underfoot in places.

3.2.6 From our inspection of the suspended ceiling void, it appears that the leaks have primarily occurred at the perimeter parapet detail and toward the underside of the integral guttering noted to the west elevation.

3.2.7 It appears that the leaks have penetrated between the bitumen felt and underlying decking which has resulted in a deterioration of the underlying decking and the delamination noted.

3.2.8 In addition to this, damp staining was noted directly to the underside of the large steel lattice beams.

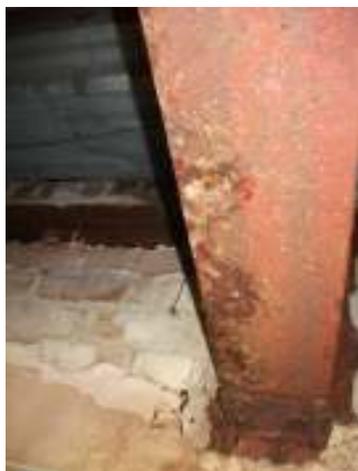
3.2.9 Where inspected, the painted fire protection to the steel beams was heavily corroded in these areas suggesting an ongoing problem for some time.

4.1.7 In addition to this work, it is strongly recommended the structural steelwork is adequately prepared and redecorated with an approved intumescent paint to provide sufficient fire protection.

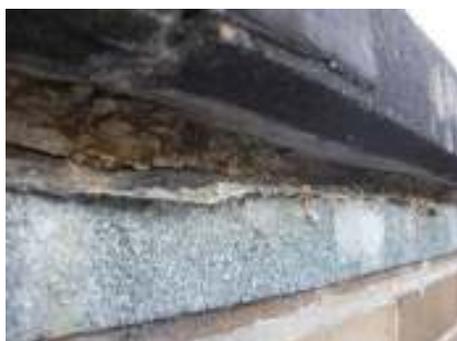
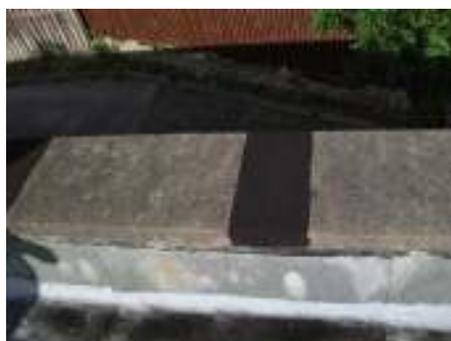
3.2.11 The overhanging drip to the concrete coping is limited to 50mm and this has been compromised where the copings have been re-pointed

3.2.12 The staining and leaks noted to the main roof appear to be principally related to a poor and failing perimeter coping detail, however as there does not appear to be any insulation provided to the roof deck, it is expected that condensation forming to the underside metal decking and steel lattice beams exacerbates the problem.

3.2.13 Felted flat roofs do have a limited lifespan and it is expected the flat roof covering will continue to deteriorate and leak until the flat roof covering is replaced and the concrete coping detail is reformed to the perimeter parapet.

3.2.14 The felted flat roof covering is expected to be at least 10-15 years old and as such, is considered to be approaching the end of its economic life span and replacement of the flat roof covering should be expected within the next 5 years.

3.2.15 At the time of the recovering, it is strongly recommended that the lack of insulation to the roof is addressed and the new roof covering specification should include adequate insulation to provide a 'warm deck' insulated flat roof.

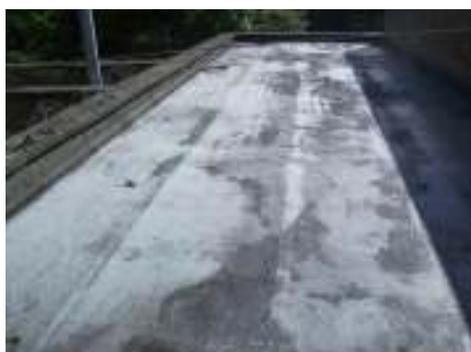
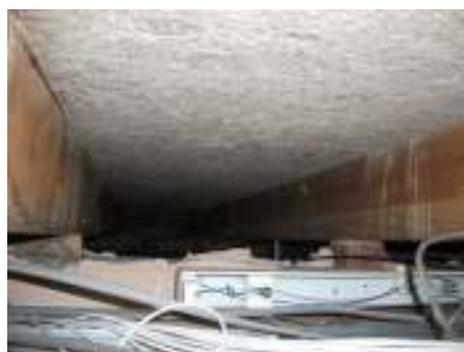
3.2.17 The flat roof over the staff areas to the rear of the building is constructed out of 'stramit' boarding on timber joists which has been laid to fall and completed with a built up bituminous roofing felt which has been further waterproofed with a proprietary waterproofing paint.

3.2.18 Although not leaking at the time of the inspection, the waterproofing paint had deteriorated in several places and it is expected that the waterproofing bituminous felt is approaching the end of its life.

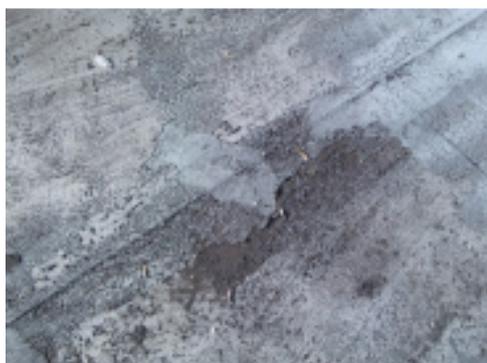
3.2.19 The flat roof is formed with a perimeter brickwork parapet wall and concrete coping detail similar to that over the main library which appears to present similar problems with evidence of damp penetration noted internally to the suspended ceiling tiles at the junction of the roof over the staff areas and the roof to the main library.

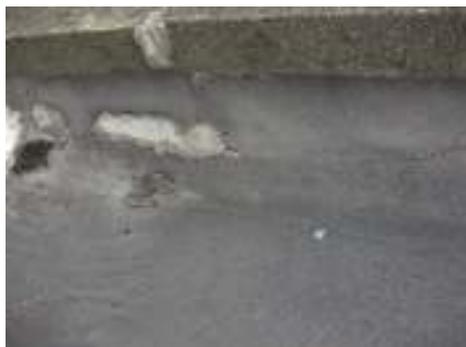
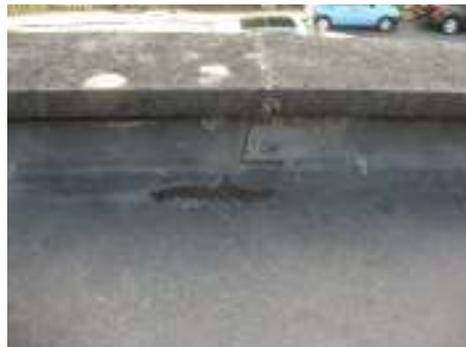
3.2.20 The flat roofs to the front and rear of the library are of suspended concrete construction covered with asphalt. The asphalt to the flat roof at the front of the property has failed and leaking to the perimeter edges and has been repaired several times in the past at the junction with the roof to the main library.

- 3.2.21 It is recommended that any refurbishment of the library would include the replacement of the failing asphalt roof with a new flat roof covering. The new covering should address the lack of insulation and the new covering should incorporate satisfactory insulation in accordance with current regulations.

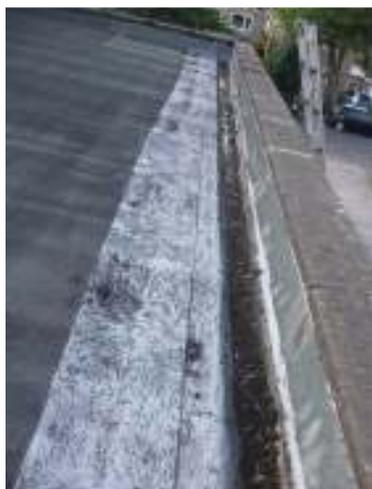
- 3.3.1 The main flat roof over the library is laid to fall to an integral gutter to the west elevation. The gutter drains to two outlets on the western parapet and cast iron guttering and hopper heads.
- 3.3.2 The integral gutter does not appear to drain correctly and was full of debris and materials suggesting standing water at the time of the inspection.

- 3.3.3 Due to the nature of the fall of the gutter, it appears that the downpipe and hopper head to the south west corner takes the majority of the rainwater drainage from the flat roof and the outlet and downpipe is obsolete.
- 3.3.4 It is recommended the replacement of the roof covering includes a rearrangement of the integral gutter to ensure rainwater drains into both of the cast iron downpipes and hopper heads.
- 3.3.5 The rainwater goods to the perimeter of the building are a combination of large diameter cast iron downpipes and hopper heads to the main building and smaller PVC downpipes and hopper heads to the flat roof areas to the front and rear.

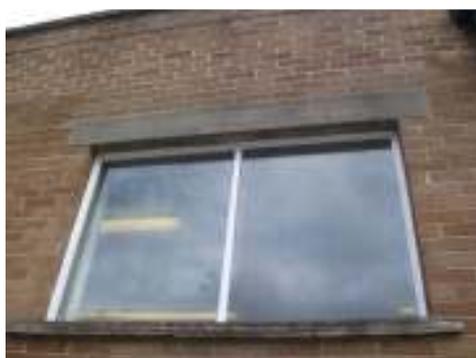
- 3.4.2 The reinforcement to three of the lintels to the west facing elevation has corroded and blown and these concrete lintels are defective and require replacing. The stone cills were generally loose and defective and require repointing.

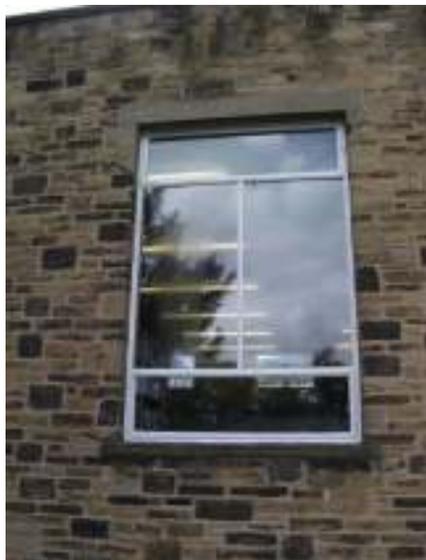
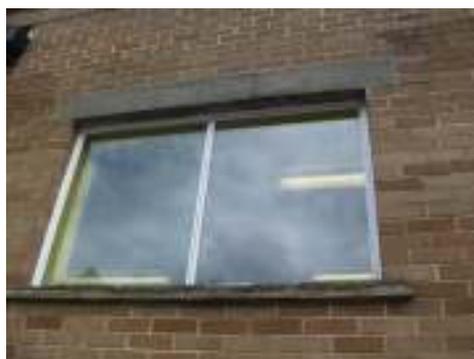
3.5.2 All of the windows appear to be painted up and generally inoperable and a large number of the double glazed units have misted up and failed.

3.5.3 As a number of the double glazed units have failed, it is an indication that the replacement glazing has generally reached the end of their economic lifespan and further failure should be expected in the coming years.

3.5.4 The retro double glazed units are limited and not considered to be thermally efficient and it is recommended that the windows to the library would be replaced as part of any refurbishment.

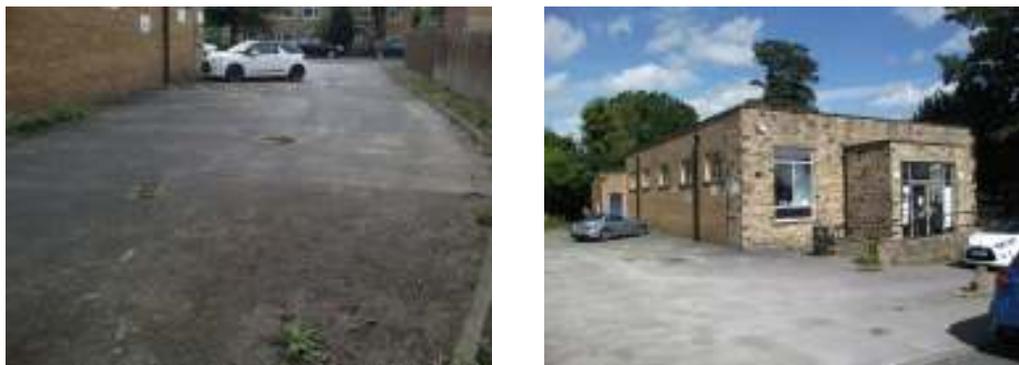
- 3.6.1 The library is provided with a tarmacadam car parking area to the west elevation with two designated disabled parking places. The finish to the tarmac car parking areas is generally uneven and in poor condition with raised inspection chamber covers noted.

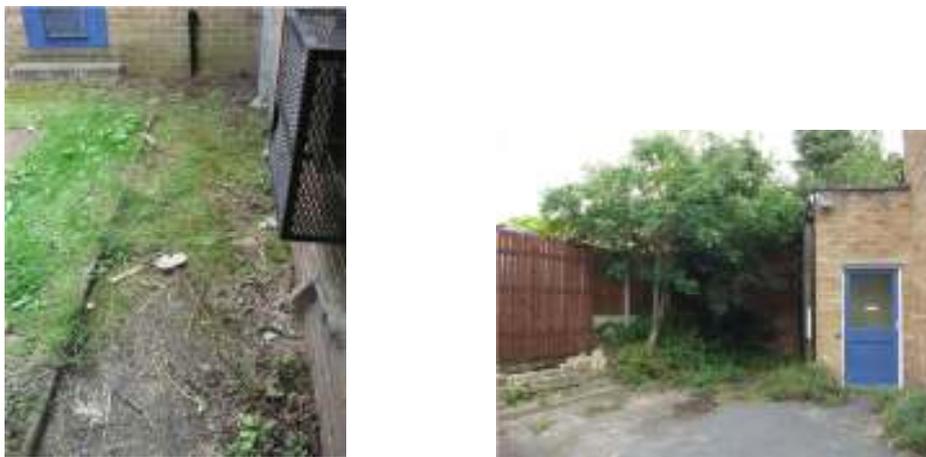
- 3.6.2 Substantial vegetation growth and moss was noted to the paths and walkways around the perimeter around the perimeter of the building together with 2 lime trees and a maple tree which are growing in close proximity to the north west corner of the building.

- 3.6.3 It is recommended that the trees growing to this corner of the building are removed by a professional arborist and the banking to the rear is retained with an adequate retaining wall.
- 3.6.4 The car parking areas and gravelled paths around the perimeter of the library which were noted as being in poor condition should be recovered with new tarmacadam.
- 3.6.5 To the front entrance, there is a sloping ramp to provide disabled access into the main entrance.
- 3.6.6 Although the gradient of the ramp appears to be acceptable and adequate handrails are provided, the concrete pavings are loose and uneven and require relaying and repointing.
- 3.6.7 As noted, the roof drains into several downpipes noted around the perimeter of the building. The grates to the access gulleys are broken and defective in places and require cleaning out, replacing and reforming.

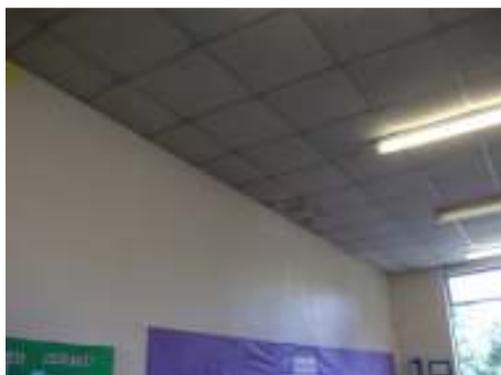
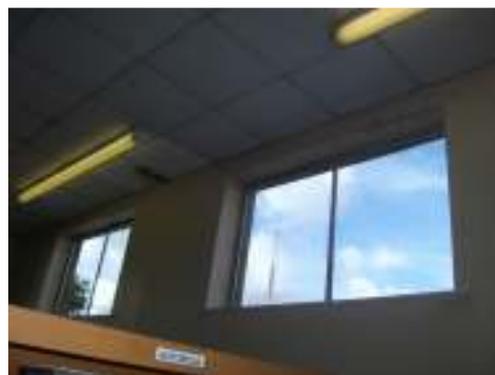
4.2.2 Both the suspended ceilings and light fittings appear to be original to the property and as such are of some age and dated.

4.2.3 The suspended ceiling grid and in-laid mineral tiles are substantially stained and marked and it is expected would be replaced as part of any refurbishment of the property.

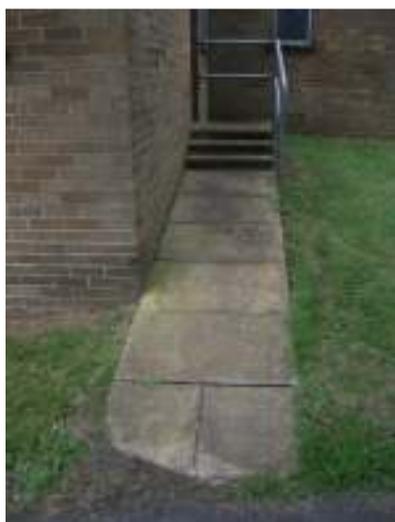
- 7.3 Although there is a ramped access to the entrance enabling wheelchair access into the library, the fire escapes to the rear of the property are not wheelchair accessible and it strongly recommended that this is revised.
